# **Tundra 3UR-FE 5.7L V8 Drive Belt Replacement**

# 3UR-FE Accessory Drive Belt Tensioner

**Service Category** Engine/Hybrid System

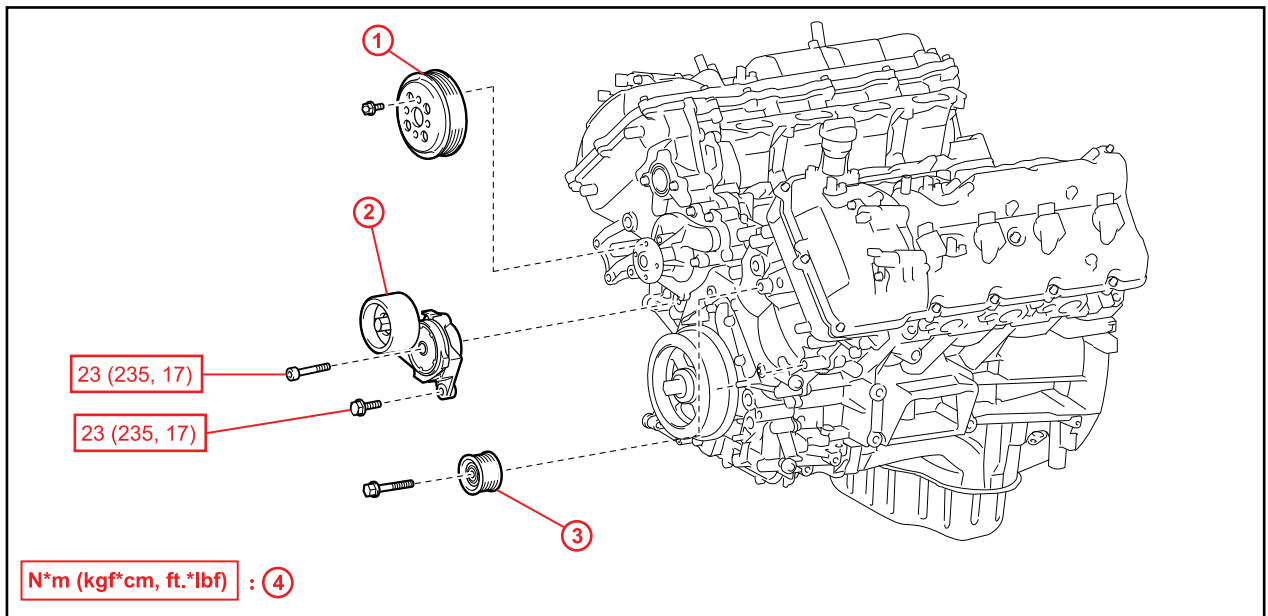
Figure 1.

Some customers may experience an abnormal noise from the engine accessory drive belt area. An improved accessory drive belt tensioner assembly has been developed to keep the tensioner pulley in alignment with the other pulleys. If the tensioner pulley is out of alignment, use the procedure in this bulletin to address the customer's concern.

2. Remove the drive belt tensioner assembly.

3. Replace the drive belt tensioner assembly.

**Torque: 23 N\*m (235 kgf\*cm, 17 ft\*lbf)**
